**Midsteeples Quarter**  
**Phase 3a Feasibility Study and Business Plan**  
113-115 & 117-119 High Street, Dumfries  
December 2019

Site 113-115 High Street: Condition survey

Site 117-119 High Street: Condition survey

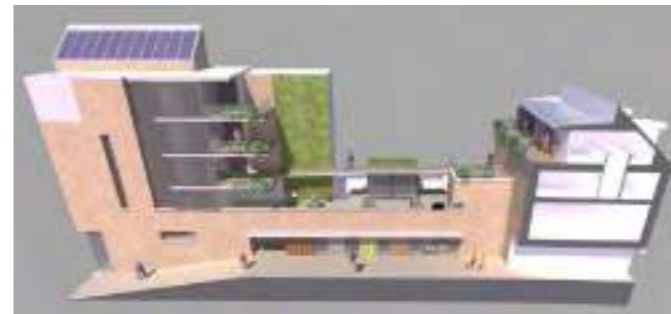
ARPL Architects masterplan for Midsteeples and Stage 3 proposals for 'The Oven'

The Oven is the first in a group of disused buildings on Dumfries High Street (no's 135-139) which Midsteeples Quarter have identified as a site for a bold initiative which will see local people developing their own High Street as a contemporary living, working, socialising, learning and enterprising hub.

The plans are to develop the building into seven new flats which will be available to rent. The street level will become a flexible enterprise space for start-up businesses and social enterprise, as well as continuing the use of the space for charities and third sector organisations. The Victorian façade of the existing building will be retained as an important element of the character of the Dumfries townscape while the remainder of the building (1980s) will be extensively remodelled to create the first new inhabited Close buildings in Dumfries in living memory. Until the renovations can begin, the ground floor space is being used as a meeting and makers space which has the flexibility to be used for events, exhibitions, music events and much more.

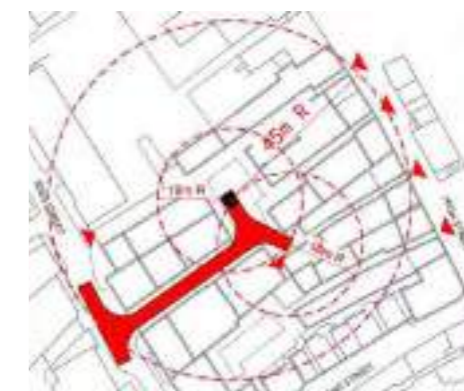
Masterplan for Midsteeple recommends former new adopted access from Irish Street

The wider masterplan identifies this constraint and proposes the formation of an adopted spur with turning head. This would allow much greater development opportunity if it were to transpire.

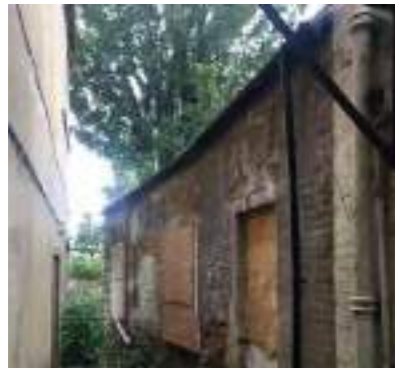
**South west end** (single storey)  
External - stone, largely altered with brick.  
Internal - mostly brick.  
**Heritage significance - Low**

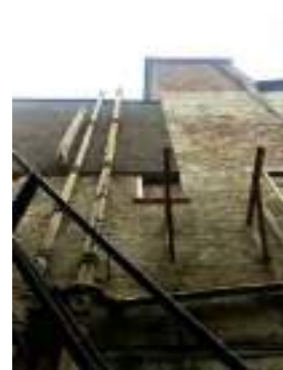
**Brick tower (inc lift)**  
External - brick (painted)  
**Heritage significance - Low**

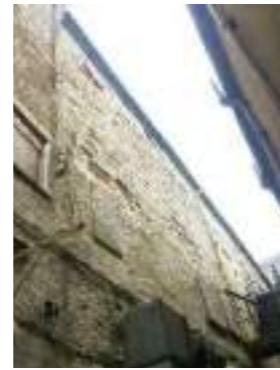
**Main section** (all storeys)  
External - stone (spalled face and painted)  
**Heritage significance - Low**

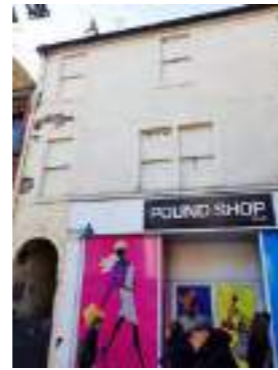
**High Street elevation**  
External - ashlar painted  
**Heritage significance - Medium**

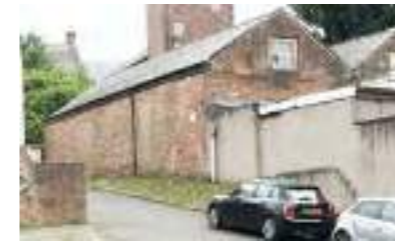
**Print workshop**  
External - stone (NW & SW) & brick (SE)  
Internal - glazed brick (NW shed), painted brick (SE shed)  
**Heritage significance - Medium**  
social/cultural significance  
Dinwiddie print studio

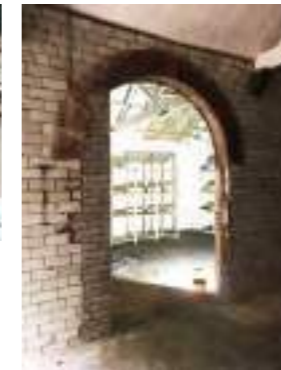
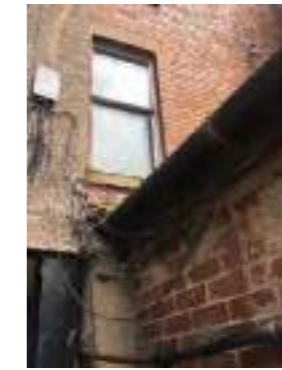
**Main section** (all storeys)  
External - brick (imperial)  
Internal - coved ceiling  
**Heritage significance - Low**

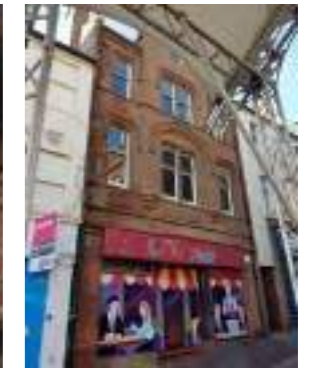
**High Street elevation**  
External - red sandstone/ashlar  
**Heritage significance - Medium**

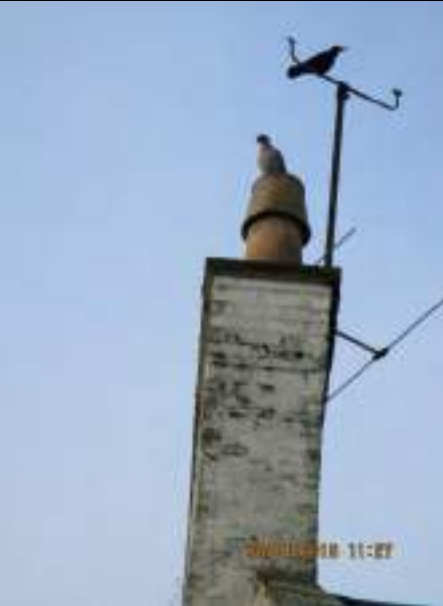
5	Outside the property	Commentary – condition and recommended works	
5.1	<b>Chimneys</b>	Very limited inspection from the ground	
	<p>Building 1 Left hand gable – Painted brick built stack; Some flues may be shared with neighbouring properties; pc concrete copings</p> <p>TV aerial on metal bracket</p>	<p>Staining and discolouration of paint finish; vegetation growing in mortar joints and from chimney capping; no lead safe visible; stepped lead cover flashings ageworn; only one visible chimney pot, redundant flues likely to be unventilated; surviving chimney pot is not fitted with a vented stopper; no major cracking or structural movement but view from ground very limited</p>

<p>Recommendation</p>	<p>The displaced capping of the left chimney requires urgent repair.</p> <p>Both chimney stacks require maintenance to leadwork, pointing, chimney heads, cappings, chimney pots and ventilation of flues</p> <p>There is extensive ingress from chimney defects. It is would be prudent</p>	<p>Condition rating 3</p>

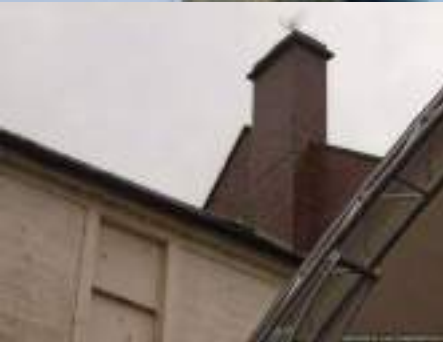
<p>Building 1 Right hand gable</p> <p>Brick built stack; Some flues may be shared with neighbouring properties; pc concrete copings</p>	<p>Staining and discolouration of brickwork; vegetation growing in mortar joints and from chimney capping; no lead safe visible; stepped lead cover flashings ageworn; only one visible chimney pot (to rear), flues likely to be unventilated; surviving chimney pot is not fitted with a vented stopper; sandstone capping is not bonded to the brickwork and is displaced</p>

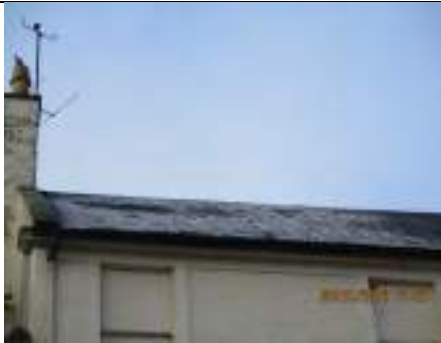
5	Outside the property	Commentary – condition and recommended works	
		to make provision for rebuilding the chimney heads to ensure their stability and install lead safes to prevent water ingress.	
5.2	<b>Roof coverings</b>	Very limited inspection of the three storey roofs from the ground. No inspection of the south side roofs. No inspection of flat roofs	
	<p><b>Buildings 1 &amp; 2 – three storey roofs</b></p> <p>Slate roof coverings</p> <p>Slating appears to be original ungraded slate.</p>	<p>Roof slating is old. There are many slipped, broken or missing slates. Significant ingress of water is occurring through roof defects</p>

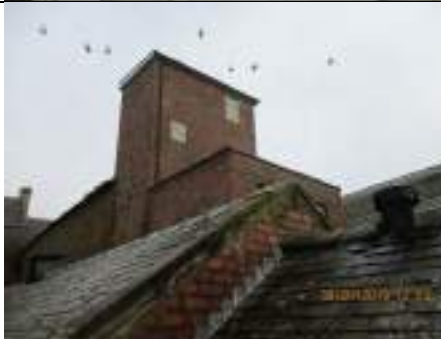
<p><b>Building 3</b></p> <p>Flat roof</p> <p>No inspection</p>	<p>There is ingress of water from roofs and visible edges are in poor condition.</p>

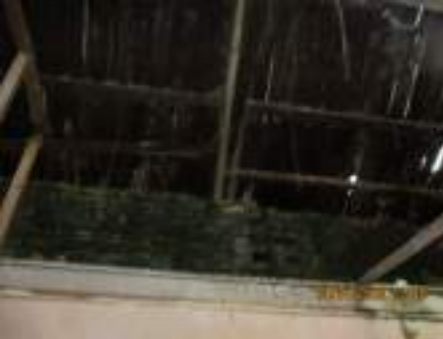
5	Outside the property	Commentary – condition and recommended works	
	<p>Building 4</p> <p>Slate roof – no external inspection</p>	<p>This building is derelict and there is widespread ingress of water, rot in sarking boards and structural timbers</p>

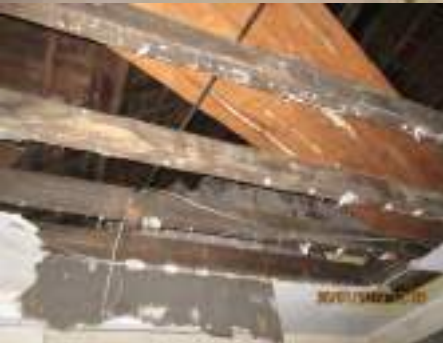
<p>Roof void</p> <p>Very limited inspection where ceiling lining has failed</p>	<p>It is to be expected that rot will have affected roof timbers and boarding where water ingress is occurring</p>

<p>Recommendation</p>	<p>The roof coverings to all the buildings require a full overhaul including renewal of roof leadwork, slates, ridge cappings and flat roofing. Some of the original slates will be reusable but most are small and unsuitable for re-use.</p> <p>The extent of rot to sarking and structural timber will only be known when opening up but significant repairs and replacement of rotted timbers will be required.</p>	<p>Condition rating 3</p>

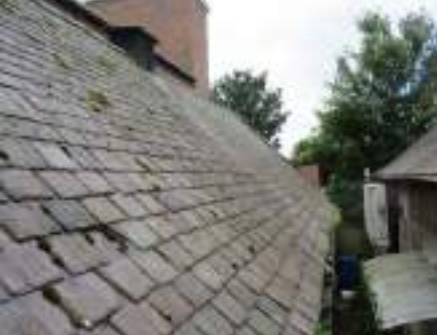
<p>Building 2, 3 and 4</p> <p>Cast iron gutters to the rear</p>	<p>Very limited inspection.</p> <p>Gutters are corroded with failed paint finishes. Gutters are generally blocked and overflowing</p>

<p>Recommendation</p>	<p>Replace all gutters and fascia boards in cast iron. Install additional drop pipes to improve capacity and provide easy and safe access for maintenance</p>	<p>Condition rating 3</p>

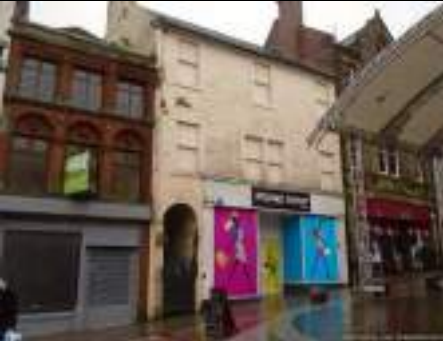
5	Outside the property	Commentary – condition and recommended works	
5.4	<b>External Walls</b>		
	<p>Building 1 front elevation</p> <p>Ashlar sandstone walls and dressed stone to doors and windows; painted on front elevation</p> <p>Shop front with inset front entrance and full width sign board</p>	<p>Stone in ageworn condition. There is cracking and some movement of stone which may be due to rot affecting structural timbers and placing additional loads on the wall.</p> <p>Paint finish is ageworn, heavily stained and with some areas flaking off the stone surface. Some weathered and missing areas of pointing and staining and weed growth due to failed rainwater goods.</p> <p>Shop front is dated and ageworn with timber framed single glazed windows.</p>

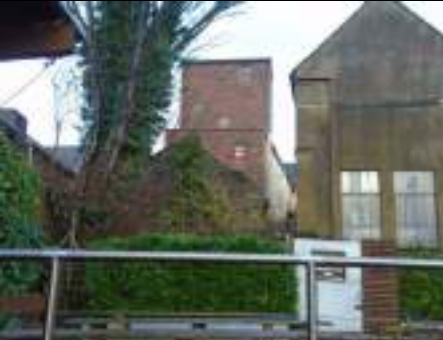
<p>Rear of Building 1 and buildings 2, and 4</p> <p>Rubble sandstone walls</p>	<p>Limited inspection</p> <p>To the extent that stone could be seen from vantage points some distance away the stone is in generally good condition. No significant cracks or distortion could be seen.</p>

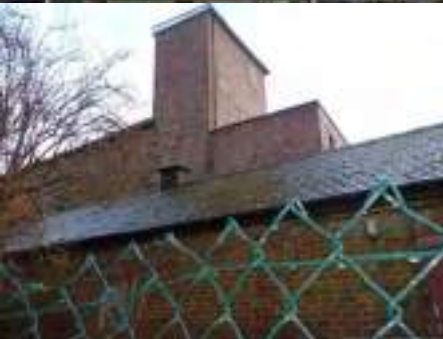
<p>Rear of Building 2</p> <p>Facing brick walls, local clay facing bricks</p>	<p>The facing brick external walls</p> <p>Limited inspection</p> <p>The walls are free from evidence of significant structural movement where seen.</p> <p>Walls are generally stained and dirty, there are area of failed mortar</p>

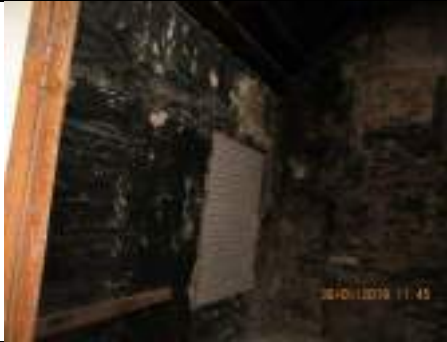
5	Outside the property	Commentary – condition and recommended works	
		pointing, and frost damage to brickwork. Flat roof coping stones are pre cast concrete and their stability could not be assessed.	
	Building 4 Sandstone rubble walling	Part stone and part brick. These walls are saturated and blackened with moss and mould growth

Recommendation	<p>Sandstone façade - Specialist cleaning required to remove staining to walls; pointing repairs in lime mortar; assess the extent and cause of movement cracks in façade.</p> <p>Check all walls for evidence of structural movement and built in structural timbers such as lintels, roof timbers or floor joists.</p> <p>Brick walls to rear require cleaning and repointing and some local repairs to damaged areas. The south elevation walls should be checked for condition and appropriate repairs carried out</p> <p>Building 4 walls should be assessed for structural integrity and stability</p>	Condition rating 3

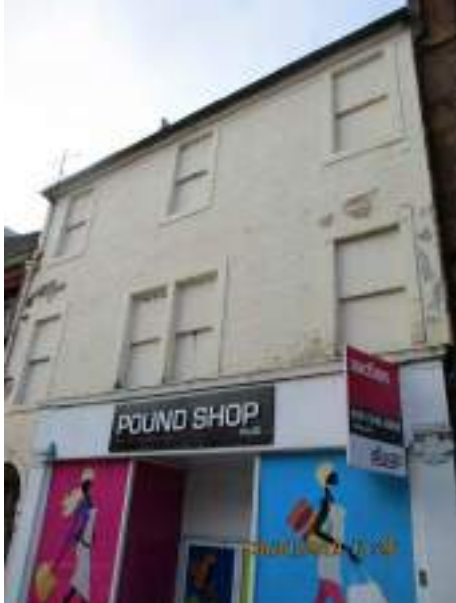
5	Outside the property	Commentary – condition and recommended works	
5.5	<b>External doors and windows</b>		
	External doors		
	<p>Shop front</p> <p>Timber framed single glazed shop front with inset entrance door</p>	<p>The shop entrance is dated and ageworn.</p> <p>Rot in timber framing</p>

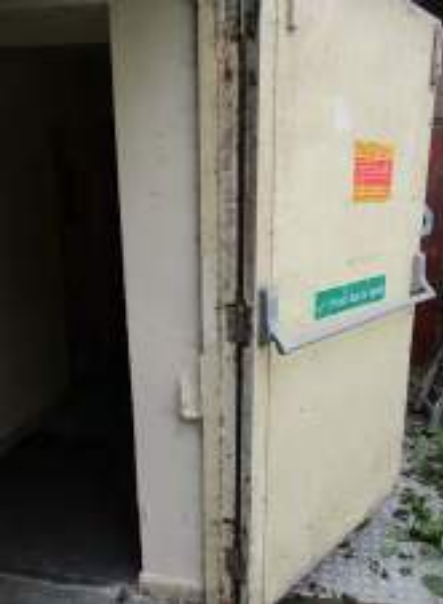
5	Outside the property	Commentary – condition and recommended works	
	<p>Rear doors</p> <p>Fire escape doors, steel lined secure doors fitted with panic bolts and slip bolts</p>	<p>All rear doors were nailed closed.</p> <p>They were in poor condition.</p>

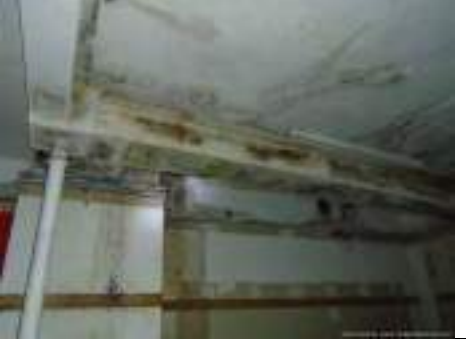
<p>Rising damp</p>	<p>There are high damp readings on walls generally. It is likely that dampness is rising from the lack of damp membranes in the original construction as well as penetrating damp.</p> <p>There are area of damage to plaster finishes at low levels and damp areas on floor slabs.</p> <p>A full assessment of the effect of rising damp defects may not be possible until the roof is overhauled and water ingress from roof defects has had a chance to dry out.</p>

<p>Recommendation</p>	<p>A specialist in the treatment of rising damp and timber disease should be asked to inspect the property and prepare a report and quotation for the necessary remedial works which should be carried out with the benefit of a long term insurance backed guarantee.</p> <p>Timbers affected by rot should be replaced or spliced</p>	<p>Condition rating 3</p>

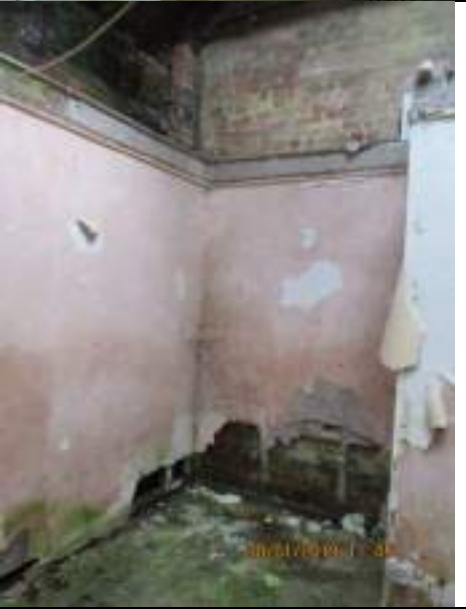
<p>Damp generally</p>	<p>High damp readings were obtained over many areas of the walls and floors. The building is unheated and high damp readings are common in the fabric of empty buildings. However there are general failures in the roof coverings and blocked rainwater conductors and water</p>

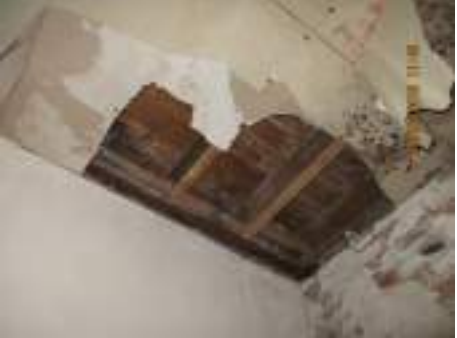
<p>Timber disease</p> <p>Dry rot</p>	<p>There is evidence of dry rot.</p> <p>The full extent was not investigated but this is an aggressive fungus and the only restriction on the spread of the fungus at present is that many areas of the building are too wet to provide ideal conditions for dry rot.</p>

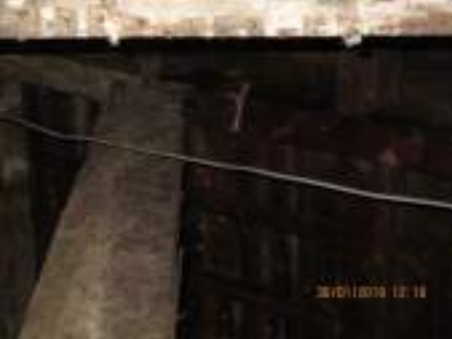
6	Inside the property	Commentary – condition and recommended works	
6.2	<b>Attic Voids</b>		
	The roof voids were only inspected where ceilings had fallen	<p>No obvious evidence of bat or mice infestation was found in the roof void.</p> <p>No obvious evidence of wasp nests or bird nesting materials in the roof space.</p>

Insulation of roof spaces	There is no insulation in roof voids where inspected.	
	recommendation	<p>Access hatches should be formed into all roof voids and inspections carried out. The condition of the roofs suggests that timber disease and infestation are likely and these should be repaired and treated as part of the roof overhaul</p> <p>Roof insulation to modern standard should be installed as part of a roof overhaul with measures to ensure adequate ventilation of cold voids and to protect against access by pests</p>	Condition rating 2

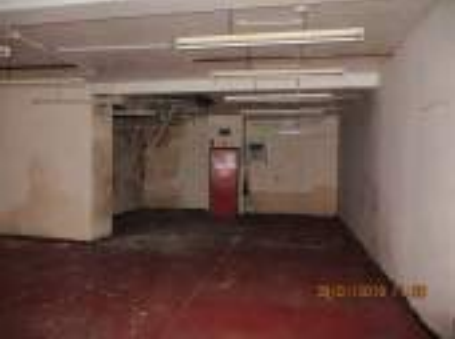
Building 4 floor slab	<p>There is some cracking in the floor slab which may be due to settlement. It is likely that the settlement is of longstanding and unlikely to be progressive</p>

Recommendation	<p>Existing vinyl tiles will require to be checked and tested for asbestos content and appropriate measures taken for removal</p> <p>A renovation of the property should include providing insulation to floors. The general level of dampness makes it likely that other repairs to floors may be required.</p> <p>Before laying new floor coverings, repairs and probably a levelling screed will be required throughout.</p>	Condition rating 3

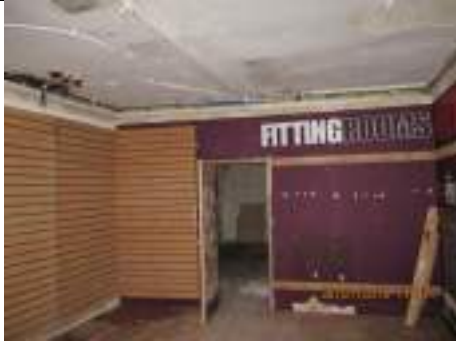
6	Inside the property	Commentary – condition and recommended works	
6.4	<b>Ceilings</b>		
	<p>Plasterboard ceilings generally</p> <p>No ceilings in building 4</p>	<p>Ceiling finishes have been affected by dampness and are in very poor condition.</p> <p>Water ingress has caused some ceiling linings to collapse</p>

Recommendation	The refurbishment works should include replacement of all ceiling finishes	Condition rating 3

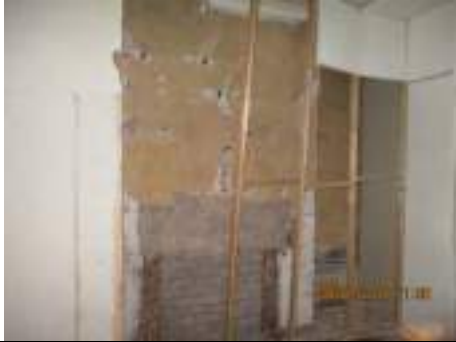
6.5	<b>Walls and Partitions</b>		
	Original lath and plaster to the external walls has been replaced or covered over by plasterboard or shop linings	All wall finishes have been affected by dampness and mould staining

Recommendation	As part of a refurbishment wall finishes should be repaired or replaced. Ideally a refurbishment might include installing insulated linings to reduce heat loss	Condition rating 3

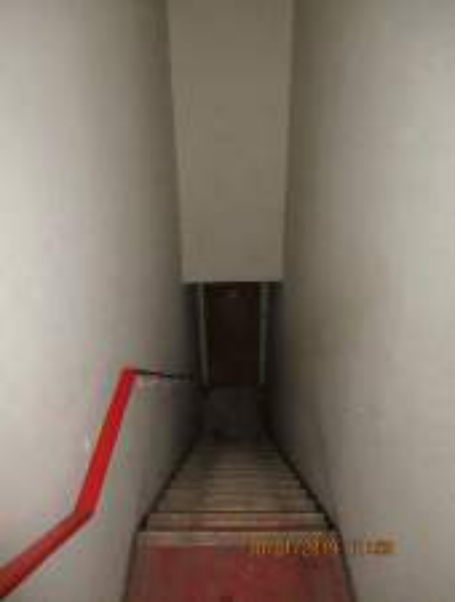
6	Inside the property	Commentary – condition and recommended works	
	the ground floor spaces. There are flues to the gable chimneys of building 1 but no fireplaces remain		
	Recommendations	As part of the chimney works the old flues should be investigated and those in ownership should be repaired and ventilated	Condition rating 2
6.7	<b>Built in fittings</b>		
	There are some shelves and work tops but in general the building has no fittings remaining		
	Stairs Stair access to the upper floors	<p>There are several stair cases. They are generally narrow and not compliant with current regulations</p> <p>The external fire escape stair is of steel construction and has suffered corrosion to the extent that it is no longer safe for use</p>

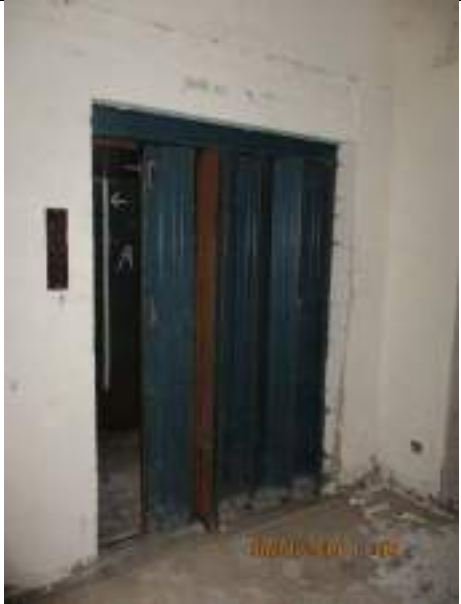
6	Inside the property	Commentary – condition and recommended works	
	<p>Goods lift</p> <p>There is a goods lift between ground and second floors of building 3.</p>	<p>The lift looks to be 40 or more years old and is unlikely to be in safe condition. The lift was not tested</p>

<p>Recommendations</p>	<p>As part of a refurbishment stair cases and fire escapes should be formed. These will require to comply with building regulations with respect to fire escape distances and protection and may involve extension to the building envelope.</p> <p>Dependent on the future use of upper floors there is likely to be a requirement to provide a lift to comply with Disability Discrimination Act</p>	<p>Condition rating 3</p>

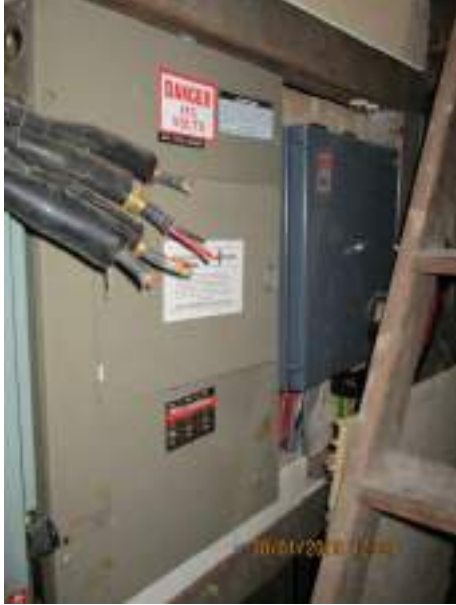
7.1	Services	Commentary – condition and recommended works	
	Generally	Services have been visually inspected but not tested. All services were turned off at the time of the inspection	
7.1	<b>Electricity</b>		
	<p>Electrical installation</p> <p>Oncoming mains supply to cellar; lighting and power installation</p> <p>Lift installation</p>	<p>There is a lighting and power installation but it is basic and outdated. Fittings and accessories are old and are likely to have been affected by damp.</p> <p>There are loose/disconnected cables at the main board</p>

Recommendation	A full replacement of the electrical installation to modern standards should form part of a refurbishment of the property.	Condition rating 3
7.2	<b>Gas/heating fuel</b>

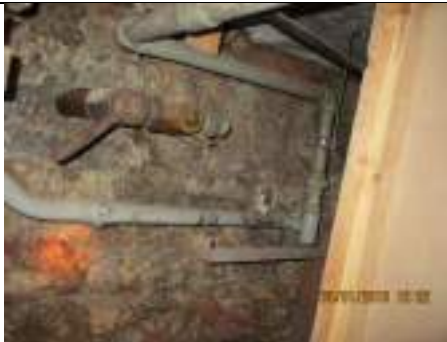
7.1	Services	Commentary – condition and recommended works	
	No gas supply	There is no gas meter or live supply but there may have been a gas supply to the cellar in the past

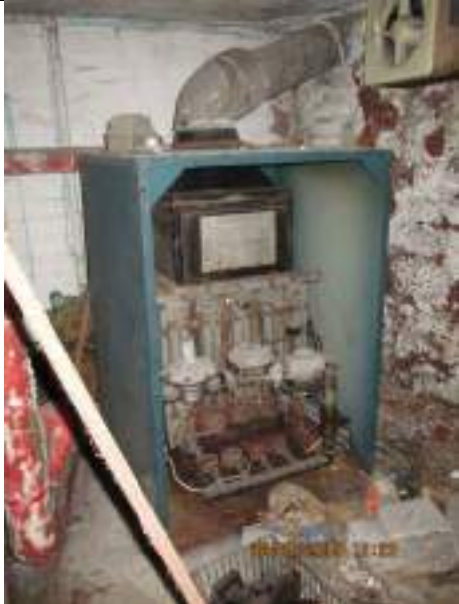
7.1	Services	Commentary – condition and recommended works	
	<p>Generally</p> <p>There is working heating system. A redundant gas boiler is located in the cellar</p>

<p>Recommendation</p>	<p>A new heating and ventilation system should be installed as part of a full refurbishment of the property</p>	<p>Condition rating 3</p>
7.5	<p><b>Hot Water</b></p>		
	<p>Sanitary installation not inspected</p>		
	<p>Recommendation</p>	<p>A new hot water system should be installed as part of a full refurbishment of the property</p>	<p>Condition rating 3</p>
7.6	<p><b>Drainage</b></p>		
	<p>Mains drainage is assumed</p>	<p>No manholes were found within the building. The provision is likely to be poor and inadequate for the future use of the building. It is assumed that drainage connections to the rear may be shared with</p>

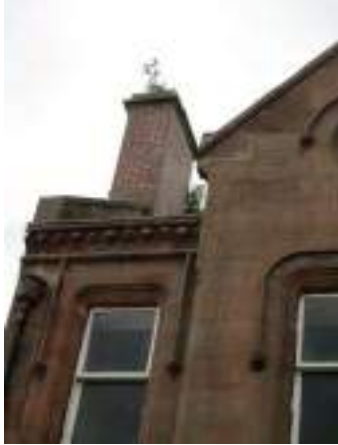
5	Outside the property	Commentary – condition and recommended works	
5.1	<b>Chimneys</b>	Very limited inspection from the ground	
	Building 1 Left hand gable - Brick built stack; Some flues may be shared with neighbouring properties; pc concrete copings	Staining and discolouration of brickwork; vegetation growing in mortar joints and from chimney capping; no lead safe visible; stepped lead cover flashings ageworn; only one visible chimney pot (to rear), flues likely to be unventilated; surviving chimney pot is not fitted with a vented stopper; sandstone capping is not bonded to the brickwork and is displaced

Recommendation	The displaced capping of the left chimney requires urgent repair.  Both chimney stacks require maintenance to leadwork, pointing, chimney heads, cappings, chimney pots and ventilation of flues There was no access to the upper floors of building 1 and the extent of ingress from chimney defects cannot be assessed. However it is would be prudent to make provision for rebuilding the chimney heads to ensure	Condition rating 3

5	Outside the property	Commentary – condition and recommended works	
		<p><a href="#">their stability and install lead safes to prevent water ingress.</a></p>

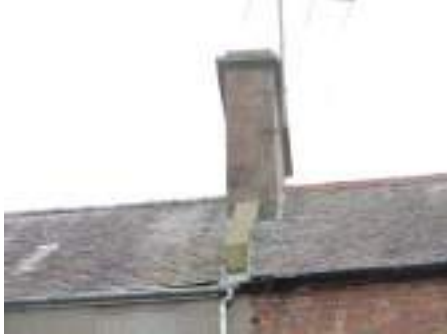
Building 1 Right hand gable  sandstone chimney; stone capping  TV aerial on metal bracket	Stone work is in generally good condition with no notable frost damage. There is some minor frost displacement of stone and cracked and missing pointing but the stack appears plumb and square. capping There is still a fireclay chimney pot visible at the front but others are missing and the flues are likely to be unventilated; surviving chimney pot is not fitted with a vented stopper. Leadwork – there is no lead safe and abutment flashings are ageworn and short. There have been untidy repairs and some mastic repairs where the lead is turned into raggles in the stone. No soakers could be seen

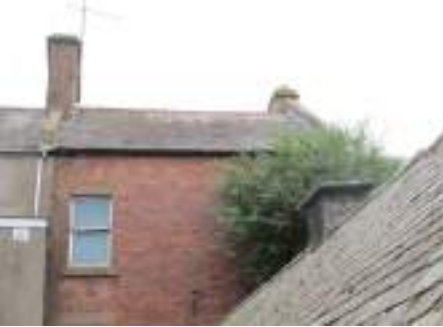
5.2	<b>Roof coverings</b>	<p>Very limited inspection of the three storey roofs from the ground. No inspection of the south side single storey roofs.</p> <p>To the rear north side the inspection was carried out from the ground and from a ladder at the eaves of the rear single storey building 3</p>	
	<p><b>Building 1 – three storey roof</b></p> <p>Slate roof coverings</p> <p>Slating appears to be original ungraded slate.</p> <p>Fireclay ridge tiles</p> <p>Stepped lead flashings at abutments to gable walls</p>	<p>Roof slating is old. There are many slipped, broken or missing slates. Dampness on the ground floor suggests that significant ingress of water is occurring through roof defects</p> <p>Lead flashings are age worn and short; soakers were not visible at abutments</p> <p>There was no access to the upper floors or roof void so the presence of sarking or roofing felt is not confirmed.</p>

<p>Recommendation</p>	<p>The roof coverings to all the buildings require a full overhaul including renewal of roof leadwork, slates and ridge cappings. Some of the original slates will be reusable but most are small and unsuitable for re-use.</p> <p>The extent of rot to sarking and structural timber will only be known</p>	<p>Condition rating 3</p>

5	Outside the property	Commentary – condition and recommended works	
		when opening up but significant repairs and replacement of rotted timbers may be required.

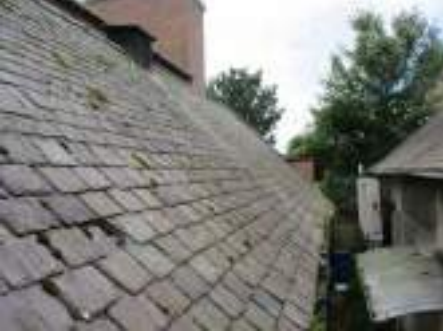
<p><b>Building 2 single storey roof</b></p> <p>Slate roof coverings</p> <p>Slating appears to be original ungraded slate.</p> <p>Concrete ridge tiles</p>	<p>Roof slating is old. There are many slipped, broken or missing slates. Dampness on the ground floor suggests that significant ingress of water is occurring through roof defects</p>

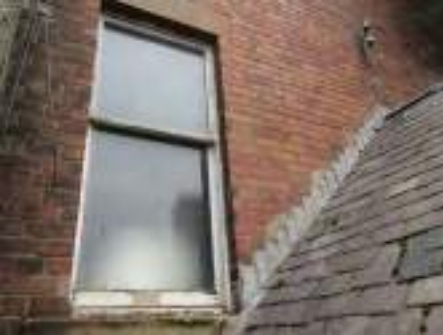
5	Outside the property	Commentary – condition and recommended works	
	Stepped lead flashings at abutments.	Lead flashings are ageworn and short; soakers were not visible at abutments

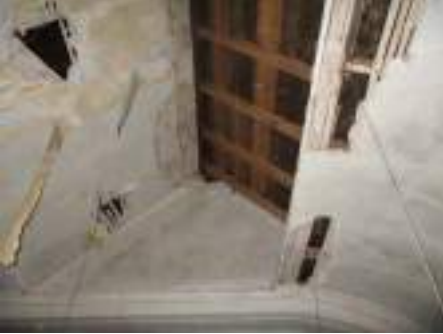
Roof void	The roof void was only open for inspection where the original roof glazing had been removed. The presence of roofing felt is not confirmed.

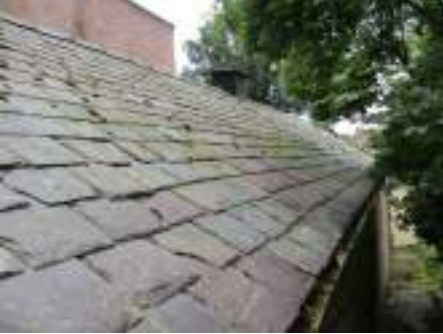
<p><b>Building 3 single storey roof</b></p> <p>Slate roof coverings</p> <p>Slating appears to be original ungraded slate.</p> <p>Concrete ridge tiles</p>	Roof slating is old. There are many slipped, broken or missing slates.

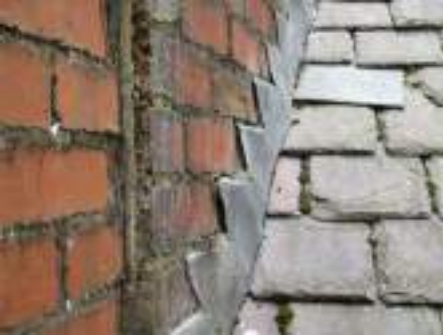
5	Outside the property	Commentary – condition and recommended works	
	Stepped lead flashings at abutments.	Lead flashings are loose, age worn and short; soakers were not visible at abutments

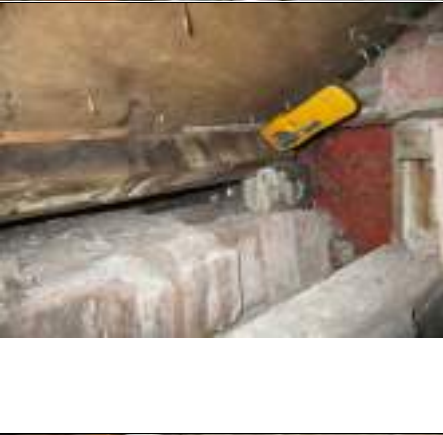
<p>There is evidence that there has been a fire in the past with some of the sarking boards having scorch marks. It is likely that timbers that suffered significant damage have been replaced such as the spliced rafter in the photo but there is a chance that further damage may be found during the roof overhaul.</p>

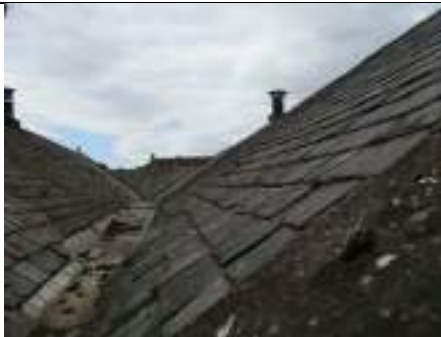
5	Outside the property	Commentary – condition and recommended works	
	<p><b>Building 4 pair of duo pitch single storey roofs</b></p> <p>Slate roof coverings</p> <p>Slating appears to be original ungraded slate. Concrete ridge tiles</p>	<p>Roof slating is old. There are many slipped, broken or missing slates. Dampness on the floor suggests that significant ingress of water is occurring through roof defects</p>

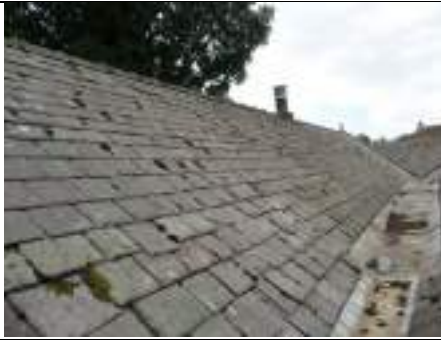
<p>Lead lined flat valley gutter</p>	<p>Ageworn leadwork. There is water penetration at various points in these roofs and it is difficult to tell whether the lead gutter lining is leaking.</p>

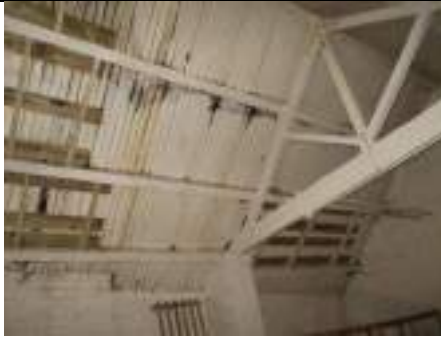
<p>Roof void</p> <p>The roof is supported on king post trusses with purlins and jack rafters</p> <p>Sarking is close boarded with tongued and grooved joints</p>	<p>The roof void was only open for inspection where the ceiling had failed due to water ingress.</p> <p>There is damp staining of timbers.</p> <p>Additional timbers have been installed, the purpose of these is unclear but may be to support (rather than replace) original sarking which has been affected by rot</p> <p>The presence of roofing felt is not confirmed.</p>

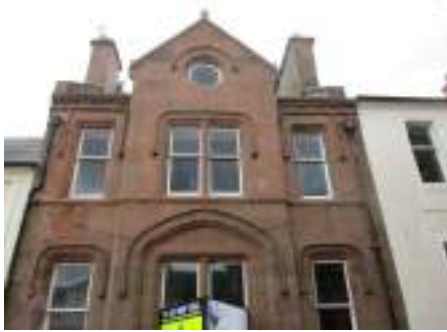
5.3	<b>Rainwater Installations</b>		
	<p>Building 1 front elevation</p> <p>Parapet gutter not inspected, presumed to be a lead lined gutter.</p> <p>Cast iron decorative hopper heads and circular drop pipes</p>	<p>Inspected from ground level.</p> <p>Staining of walls and weed growth show that water is leaking from down pipes due to corrosion in downpipes and blockage of hopper heads. Water ingress at the eaves cannot be assessed due to lack of access to upper floors and roof voids but it is likely that lack of maintenance will have led to water ingress and affected timber wall plates, rafter ends and sarking boards are likely to be affected by timber disease.</p>

Recommendation	Replace all gutters and fascia boards in cast iron. Install additional drop pipes to improve capacity	Condition rating 3

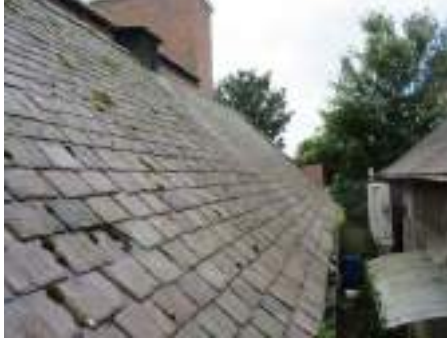
<p>Building 2, 3 and 4</p> <p>PVC gutters and timber fascia boards</p>	<p>The original cast iron has been replaced with modern PVC gutters. These are misaligned, dirty and blocked.</p> <p>There is evidence of rot affecting the fascia boards and the wall plates, rafter ends and sarking boards have been affected by water ingress and have been affected by timber disease. Some wall plates and rafter feet are missing due to the effect of rot.</p> <p>The south elevation of buildings 2,3 and 4 were not accessible for inspection but are assumed to be in similar condition to the north elevation</p>

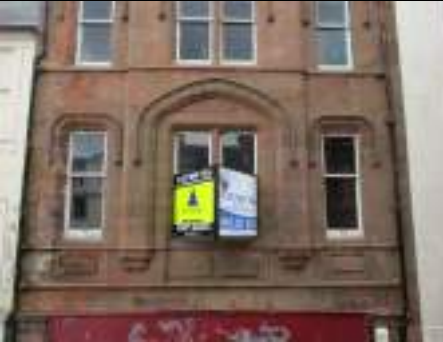
<p>Rear of Building 1 and buildings 2, and 3</p> <p>Facing brick walls, local clay facing bricks</p>	<p>The facing brick external walls are of stretcher bond which suggests they are of cavity construction.</p> <p>The walls are free from evidence of significant structural movement to the north elevation. We did not gain access to inspect the south elevations.</p> <p>Walls are generally stained and dirty, there are area of failed mortar pointing, graffiti and poor infill to former openings</p>

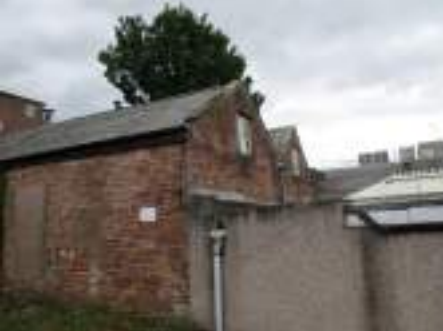
<p>Building 4 has one of its original gable windows</p>	<p>The one remaining window is in very poor condition with the lower sash hanging open. There is a roof beneath the window but when the sash falls it could cause damage and debris may fall to the roadway.</p>

<p>Recommendation – windows</p>	<p>Timber sash and case A specialist joiner should be asked to inspect the windows, prepare a schedule of repairs and carry out the necessary repairs. Where repairs are not practicable replacement windows should match the appearance of the existing windows.</p>	<p>Condition rating 3</p>

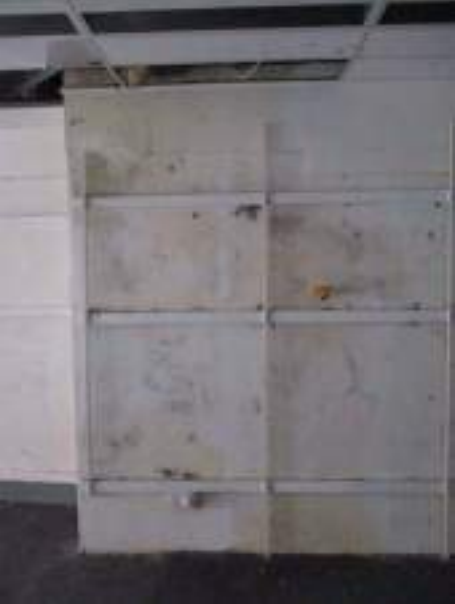
Penetrating damp Building 2	A suspended ceiling has been installed under the original vaulted ceiling. There is damage and missing panels to the suspended ceiling and some of this damage may be due to water ingress from the roof. The supporting walls of this building have high damp readings with areas of staining and mould growth. There is likely to be timber disease affecting timbers in the roof

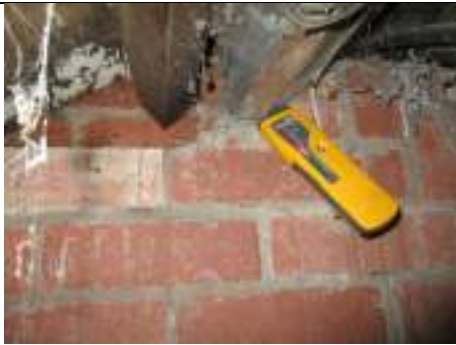
Penetrating damp Building 4	There is damp staining and damage to roof timbers as a result of water penetration of the roof covering and gutters

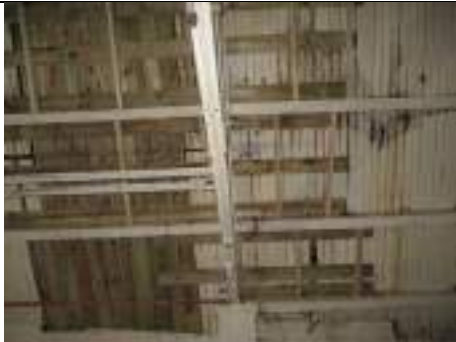
Rising damp	<p>There are high damp readings on walls generally. It is likely that dampness is rising from the lack of damp membranes in the original construction as well as penetrating damp.</p> <p>There are area of damage to plaster finishes at low levels and damp areas on floor slabs.</p> <p>A full assessment of the effect of rising damp defects may not be possible until the roof is overhauled and water ingress from roof defects has had a chance to dry out.</p>

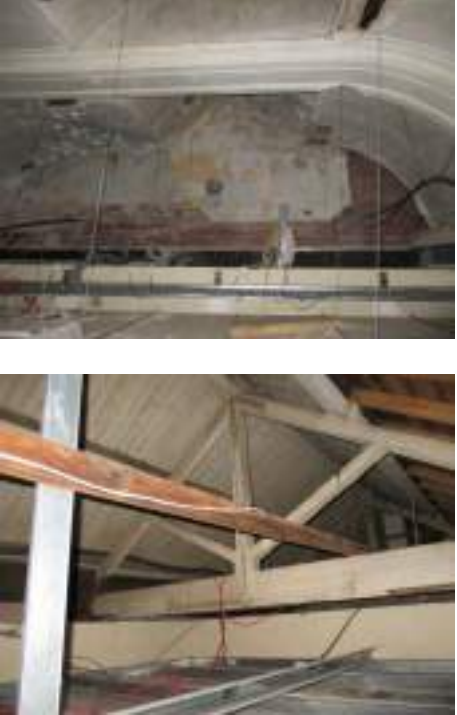
<p>Timber disease</p> <p>Dry rot</p>	<p>No evidence of dry rot was found in the timbers that could be seen.</p> <p>However the upper floors and roof space of building 1 was not inspected. The evidence of dampness on the ground floor makes it highly likely that severe rot will be affecting timbers in the roof and upper floors of these areas.</p>

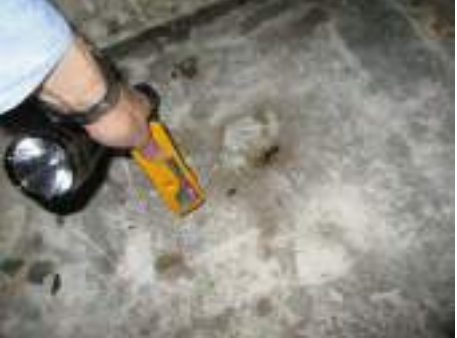
Building 4 floor slab	<p>There is some cracking in the floor slab which may be due to settlement. It is likely that the settlement is of longstanding and unlikely to be progressive</p>

Recommendation	<p>A renovation of the property should include providing insulation to floors. The general level of dampness makes it likely that other repairs to floors may be required.</p> <p>Before laying new floor coverings, repairs and probably a levelling screed will be required throughout.</p>	Condition rating 2

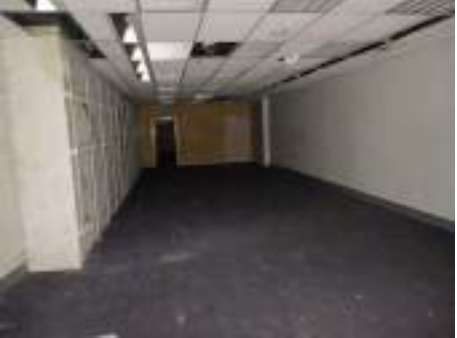
Plaster ceiling to building 3	Damp and mould staining and some damaged areas. Plasterboard is supported on a metal channel support system

Recommendation	The refurbishment works should include replacement of all ceiling finishes	Condition rating 3

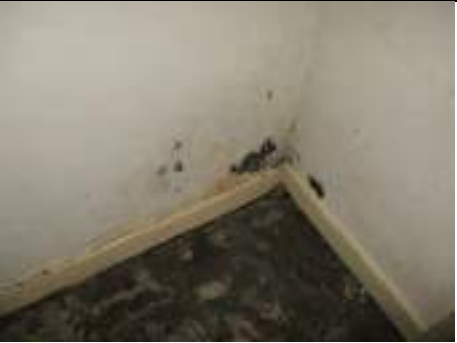
Building 4  Former print works has a wall lining of white ceramic bricks	There are areas of damage, staining and infill of former openings in fair faced blockwork.  There is historic interest in this feature

Recommendation	As part of a refurbishment wall finishes should be repaired or replaced. Ideally a refurbishment might include installing insulated linings to reduce heat loss	Condition rating 3

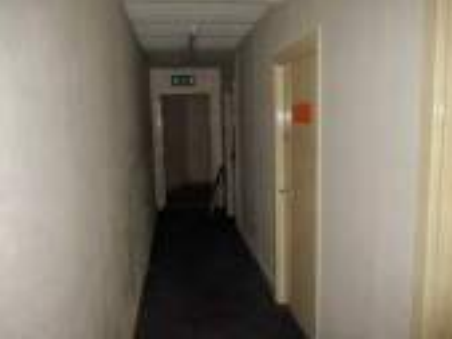
Door frames and skirtings plain profile with paint finish	All timber affected by damp. Drying may cause warping, splitting and distortion.

Recommendation	Repairs and renewals as part of refurbishment	Condition rating 2
6.9	<b>Internal decoration</b>		
	Painted finish to walls, ceilings, skirtings, doors, frames and windows	Decoration is in poor condition and has been affected by damp	
	Recommendation	The building will require full redecoration once dried and refurbished	Condition rating 3

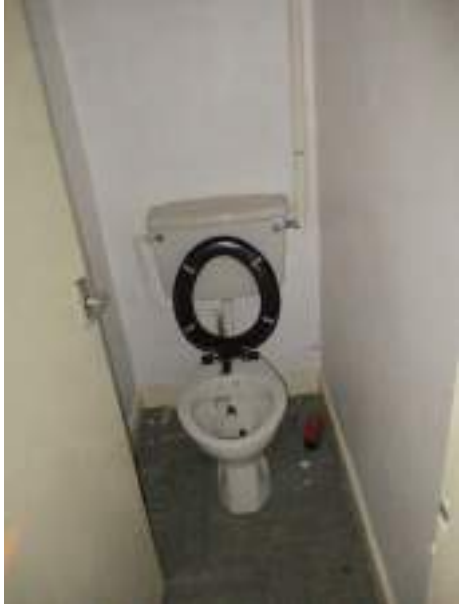
6	Inside the property	Commentary – condition and recommended works	
6.10	<b>Sanitary ware</b>		
	<p>Staff toilet</p> <p>Wash basin with over sink hot water heater</p> <p>WC suite</p>	<p>The sanitary ware is ageworn and the provision does not meet modern standards.</p> <p>There is no accessible toilet</p>

Recommendation	The provision of sanitary facilities should be considered in the design of refurbishment works	Condition rating 3

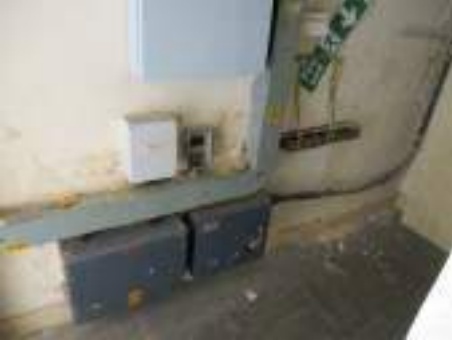
Incoming electrical supply	<p>The electrical supply cable runs along the outside wall of buildings 2 and 3 in the north close.</p> <p>There are loose and disconnected cables on the outer walls</p>

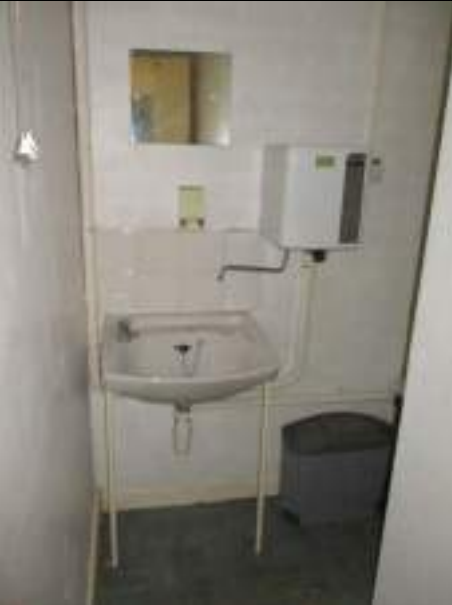
7.1	Services	Commentary – condition and recommended works	
7.5	<b>Hot Water</b>		
	Wash basin  Over sink water heater	Ageworn

Recommendation	A new hot water system should be installed as part of a full refurbishment of the property	Condition rating 3
7.6	<b>Drainage</b>		
	Mains drainage is assumed	No manholes were found within the building or in the north close. The provision is likely to be poor and inadequate for the future use of the building. It is assumed that drainage connections to the rear will be shared with other buildings before reaching a sewer

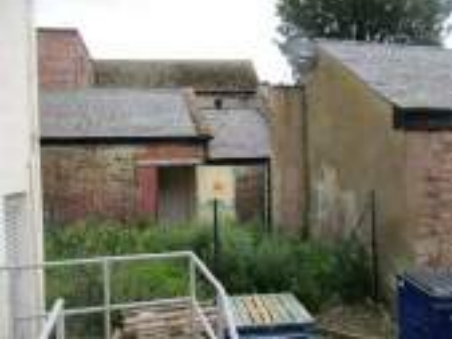
8.1	Site access	Access is only available at present from the High Street main entrance. The rear access has been blocked to the rear of WH Smiths by the construction of a fence along the boundary

Recommendation	Consideration of access will be essential to enable construction works for refurbishment or alterations to take place	Condition rating 3

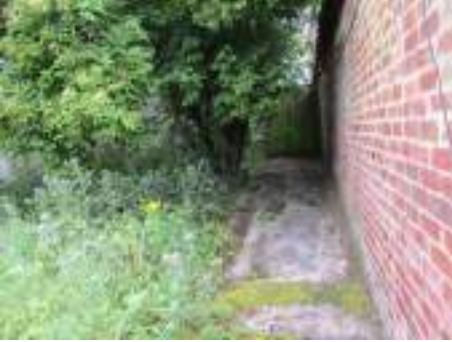
8.2	Soft landscaped areas  There an enclosed grass area at the north side of building 3	The gardens are overgrown. Before the fence was erected by WH Smith the area was misused by the public

Recommendation	Garden ground and soft landscaping will require to be design and built to suit the development proposals for the site	Condition rating 2
